AERIAL THERMOGRAPHY SURVEYS FIND INSULATOR AND OTHER PROBLEMS

By Derrick Brydges, Hydro One

This article will examine the application of aerial thermal imaging surveying on a transmission electrical system, and new applications involving insulator failure detection and new research in wood arm deterioration.

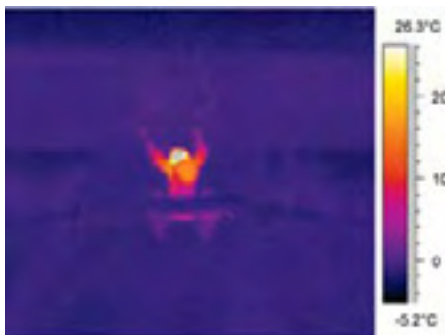
IR image of a Skywire hardware anomaly.

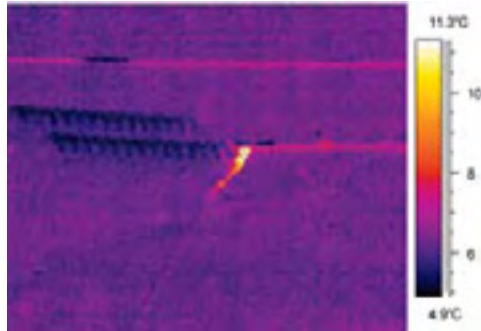
IR image of 230 kV bolted connector

The most common anomaly detected is the bolted pad, which consists of two separate aluminum pads which are connected together with steel bolts and a spring loaded Belleville washer which are tightened with a pre-set torque value. This setup applies the proper pressure between the two aluminum pads. When the proper force is no longer available to the two pads, a resistance will generate heat. There are two detailed articles in the Maintenance Technology magazine. The titles are "The Trouble with Torque in Electrical Connectors" and "Creating Reliable Electrical Connections".

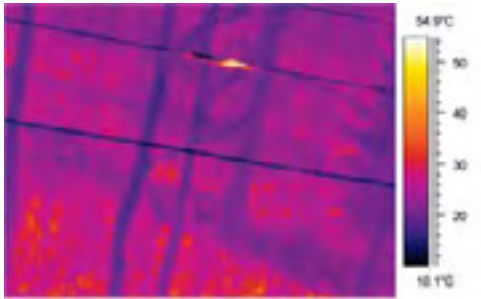
Conductor sleeve anomaly.

Another component that commonly shows up as an anomaly is conductor splices. These are used to connect the two ends of wire where the reel ends. In the transmission lines, due to the size and tension requirements of these wires, a steel core is found inside the aluminum sleeve.

In preparation for installing one of these splices, the steel sleeve is pressed onto the small diameter steel core, then the larger aluminum sleeve is installed over the top. The steel is used for strength and the aluminum for current transfer. During the preparation process, a joint compound is applied. This thin film of black compound is applied after cleaning the aluminum and may extend past the end of the connector. Without the proper settings on an IR camera, this product can give a false image of an anomaly.

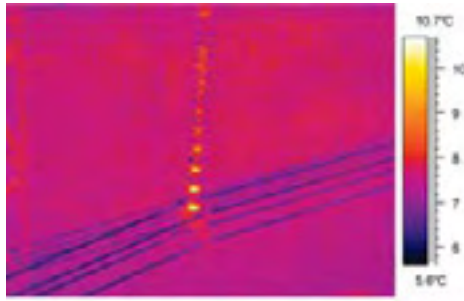
Under operational conditions, the porcelain skirt can crack which may not be detected by the naked eye. This results in causing an undesirable leakage. A good insulator behaves as a resistor and capacitor, hence any resistive leakage current will cause the metal hub to rise in temp. Once this happens, the infrared camera will detect an anomaly.

IR image of a 500 kV insulator string.

tive insulators. Once this number has been reached, the insulation value of the string has been compromised and replacement will be scheduled. If the infrared camera survey records a few anomalies, there will be a follow-up visit from a crew to test the rest of the string with the Hi-test insulation tester. The Hi-test insulation tester is a 10 kV di-electric device that is isolated from the line allowing the insulators to be tested while energized. If the infrared survey detects the minimum number of suspect insulators, the string will be replaced immediately without a follow-up Hi-test insulator program.

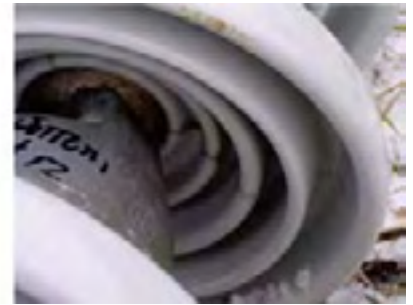
Cracked insulator skirt.

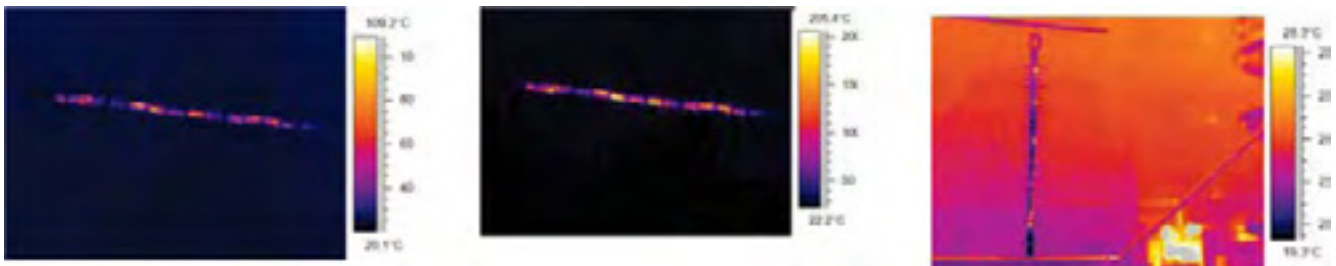
manufactured, the rubber is bonded to the fiberglass rod to eliminate voids. From the lab tests performed, it was determined that lack of bonding between the rubber housing and the fiberglass rod contributed to failure.

ThermoVision Measurements on NCIs.

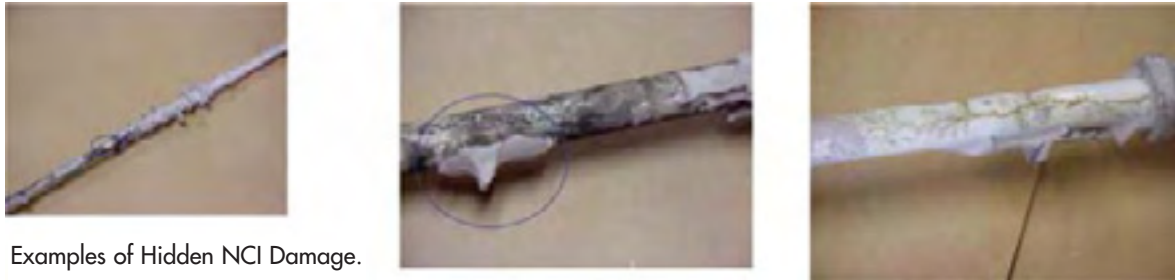
Examples of Hidden NCI Damage.

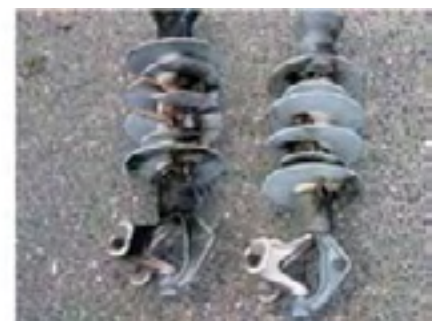
Flashed Insulators.

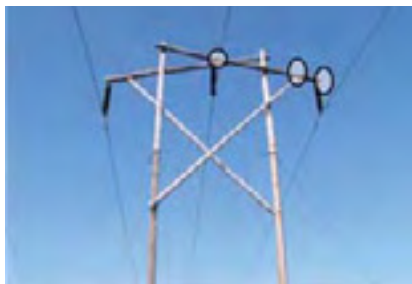
230 kV pole structure showing suspect locations of high failures
