TURNKEY SOLUTION HELPS ENTERGY REDUCE DOWNTIME AND LOST REVENUE DUE TO FAILURE OF A KEY TRANSFORMER

Entergy, one of the world's largest Investor Owned Utility companies, owns and operates White Bluff Plant, a coal-fired power generating station in Redfield, Arkansas. Entergy experienced a winding failure in one of their generator step up transformers (GSU) at this location that crippled their ability to supply power. The failed transformer represented fully half of their capacity at White Bluff.

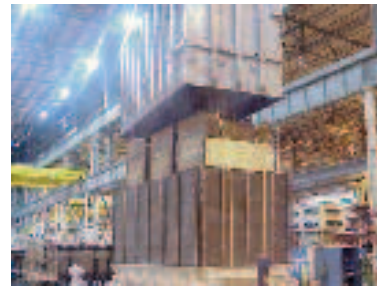
Tank lowered over core and coils
