A CLOSE LOOK AT FAULT ZONE ANALYSIS

By Amy Dalrymple, PdMA Corporation, Technical Support & Training and Product Development

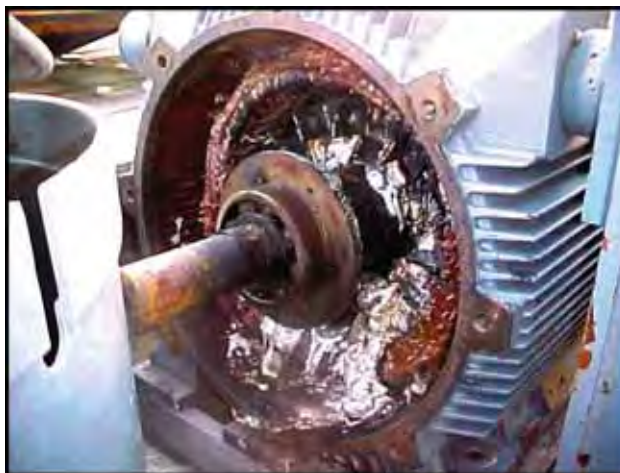
The end result in this picture is that the motor is completely destroyed, but what started it? Was it a bearing fault, excessive starts, or a poor ventilation system? In this example, the rotor was locked when it started and could not

Figure 1: Squirrel Cage Rotor

reach running speed. The resultant high currents overheated the rotor, stator, shaft, and other components in the motor. Inspection later revealed that the overloads in the power circuit had failed and did not trip the motor, resulting in complete destruction of the motor.

Looking at Figure 1 can you determine what caused the motor failure?

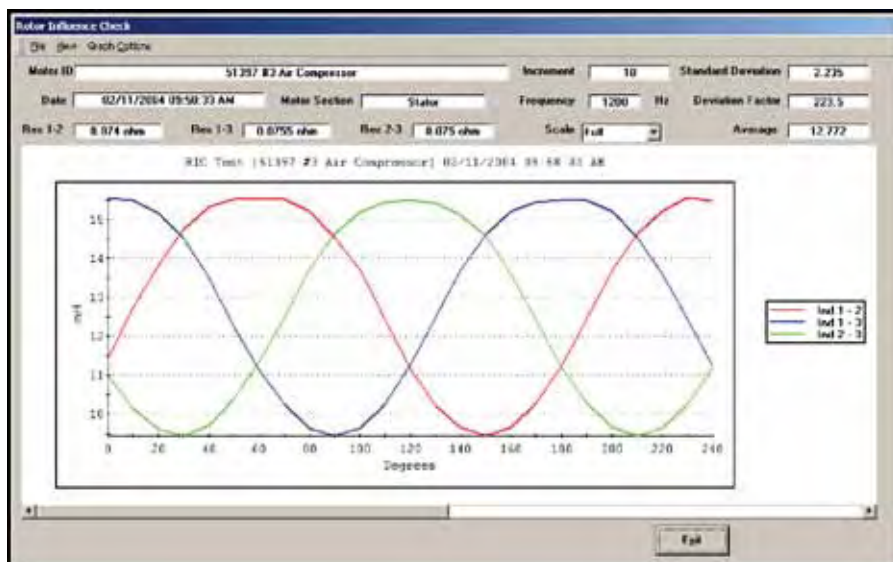
Figure 2: Satisfactory RIC Results

The MCE RIC utilizes inductance measurements to create a graphical representation of the rotor-stator relationship. Figure 2 is an example of satisfactory results for a RIC test. Positioning the rotor through 18 points of one complete pole face in specific increments, determined by the amount of poles of the motor, allows us to analyze not only winding condition, air gap eccentricity, but rotor bar condition as well.

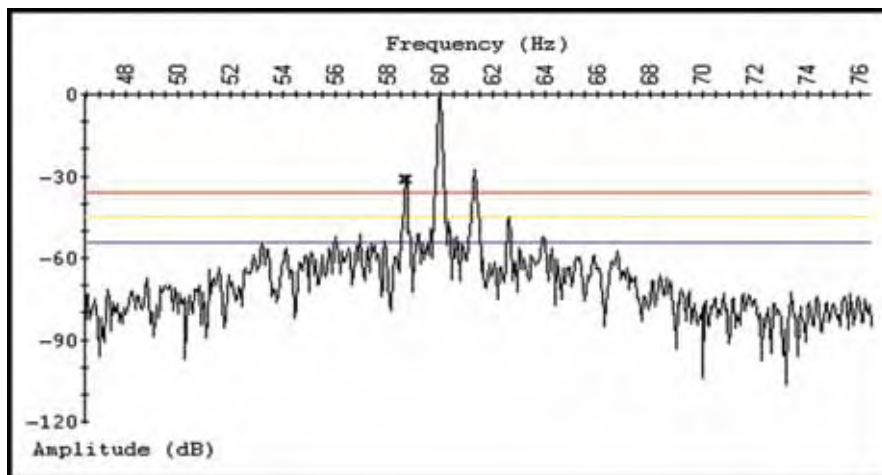
By identifying the speed of the motor, either through the EMAX Demod test or the use of a tachometer, the technician determines the FP. Rotor bar issues reveal themselves as FP sidebands at the fundamental line frequency. Figure 4 shows these FP sidebands at the 60 Hz line frequency peak for a 4-pole induction motor. The FP in this test was 1.29 Hz. Once identified, the amplitude of these sidebands in relation to the line frequency peak is used to diagnose rotor condition.

Figure 4: Motor Current Spectrum

The presence of the swirl effect is an additional indication of possible rotor problems. Note the swirl effect in the motor current spectrum shown in Figure 5 from the same 4-pole motor discussed earlier. The frequency span between the swirl peaks is 1.29 Hz, which is equal to the FP identified in Figure 4.
