AERIAL THERMOGRAPHY SURVEYS FIND INSULATOR AND OTHER PROBLEMS

By Derrick Brydges, Hydro One

This article will examine the application of aerial thermal imaging surveying on a transmission electrical system, and new applications involving insulator failure detection and new research in wood arm deterioration.

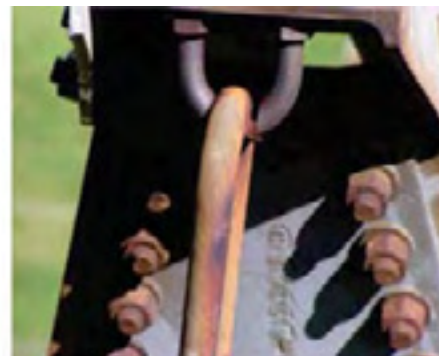
Once an anomaly is detected, a closer view can be established.

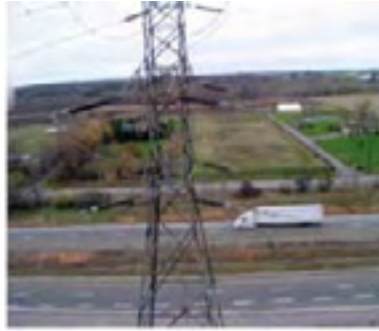
230 KV Dead end tower

The most common anomaly detected is the bolted pad, which consists of two separate aluminum pads which are connected together with steel bolts and a spring loaded Belleville washer which are tightened with a pre-set torque value. This setup applies the proper pressure between the two aluminum pads. When the proper force is no longer available to the two pads, a resistance will generate heat. There are two detailed articles in the Maintenance Technology magazine. The titles are "The Trouble with Torque in Electrical Connectors" and "Creating Reliable Electrical Connections".

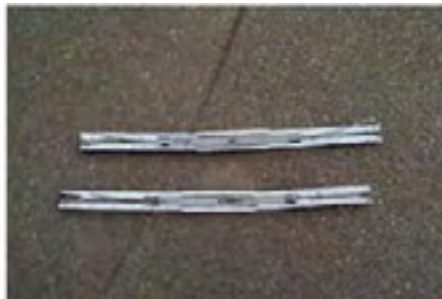
Aluminum conductor sleeve with Inner Steel Core sleeve.

Another component that commonly shows up as an anomaly is conductor splices. These are used to connect the two ends of wire where the reel ends. In the transmission lines, due to the size and tension requirements of these wires, a steel core is found inside the aluminum sleeve.

In preparation for installing one of these splices, the steel sleeve is pressed onto the small diameter steel core, then the larger aluminum sleeve is installed over the top. The steel is used for strength and the aluminum for current transfer. During the preparation process, a joint compound is applied. This thin film of black compound is applied after cleaning the aluminum and may extend past the end of the connector. Without the proper settings on an IR camera, this product can give a false image of an anomaly.
